NASA CR-134816
GESP-695

T-111 RANKINE SYSTEM CORROSION TEST LOOP

Volume II

Nuclear Systems Programs Missile and Space Division
GENERAL ELECTRIC COMPANY

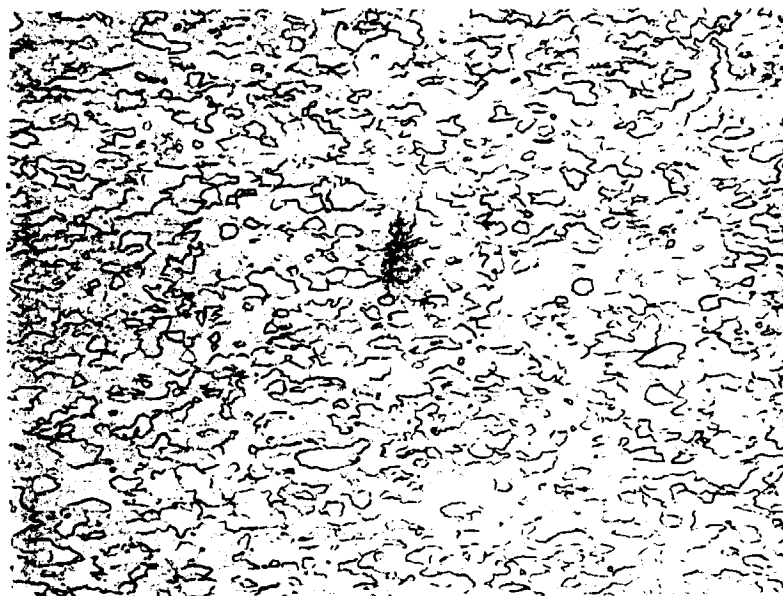
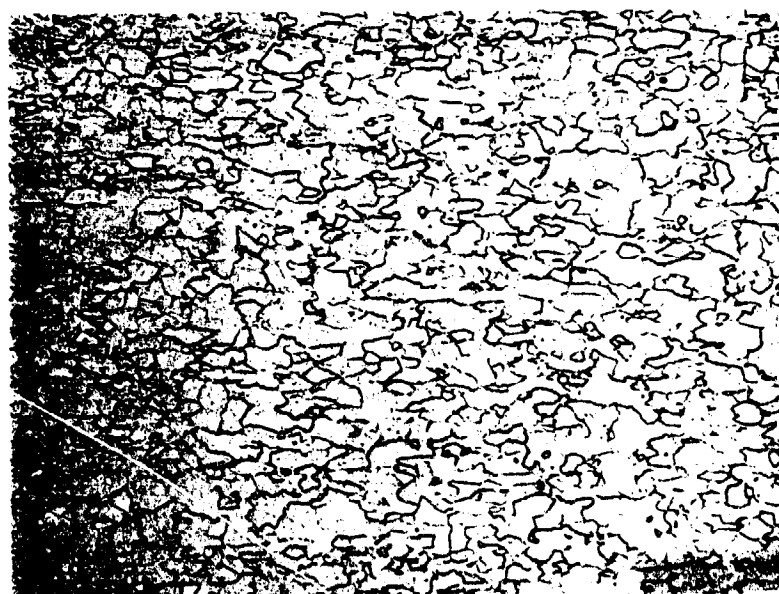
a) Annealed, 500°F (1371°C) - 1 Hour

b) Annealed, 2600°F (1427°C) - 1 Hour C1127-2

Figure L-10. Longitudinal Microstructure of T-111 Alloy Tubing After First Reduction.

Recovery and/or recrystallization have occurred in the annealed specimens shown in Figures D-9 through D-12. The microhardness and grain-size data are presented in Table D-IV. A one-hour anneal at 2700°F (1482°C) was selected to obtain a desirable combination of hardness and grain size. The tube was further reduced, annealing after each 50 percent reduction, to produce the 1.00-inch (2.5-cm)-OD x 0.10-inch (0.25-cm)-wall and 0.375-inch (0.95-cm)-OD x 0.065-inch (0.17-cm)-wall tubing. After cleaning and wrapping in tantalum foil, both the 1.00-inch (2.5-cm)-OD and 0.375-inch (0.95-cm)-OD tubing were given a final anneal for 1 hour at 3000°F (1649°C).

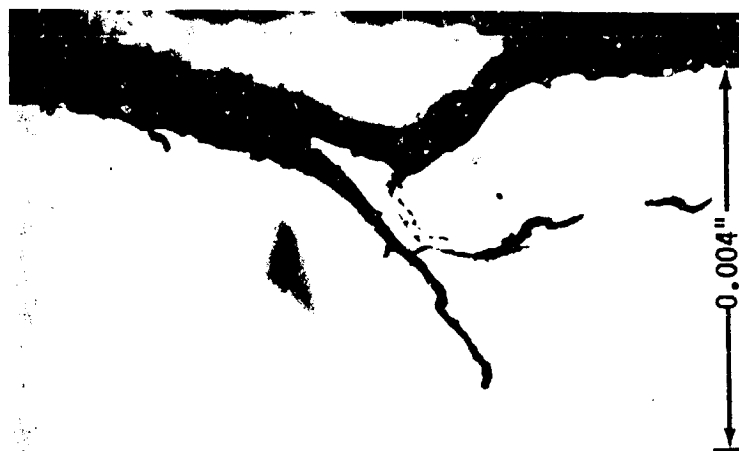
(a)

Figure D-13. Photomicrographs of Typical Defects on the ID Surface and Inner Wall of 0.375-Inch (0.95-cm)-OD x 0.065-Inch (0.16-cm)-Wall T-111 Alloy Tubing.

The final vendor inspection and testing of the T-111 alloy, 0.375-inch (0.95-cm)-OD x 0.065-inch (0.17-cm)-thick-wall and 1.0-inch (2.5-cm)-OD x 0.100-inch (0.25-cm)-thick wall tubing found the tubing to be free of rejectable defects. However, subsequent quality assurance inspection by ultrasonic testing at General Electric revealed numerous ID and OD defects in the 0.375-inch (0.95-cm)-OD tubing. Many of the defects were identified by visual examination, using a stereomicroscope, as OD defects of the scratch type which were apparently introduced during handling prior to receipt by General Electric. These defects were easily benchbed out. With the majority of the OD defects removed, the remaining ID defects were easier to identify in a second ultrasonic inspection. ID defects which exceeded the specification requirements were removed from the tube by sectioning. The metallographic appearance of typical ID defects of this type is shown in Figure D-13.

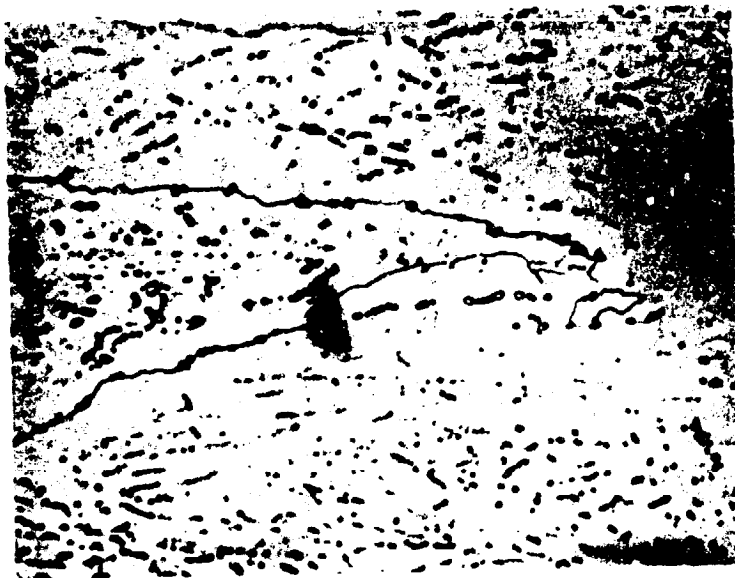
a) Annealed 1 Hour at 2600°F (1427°C)

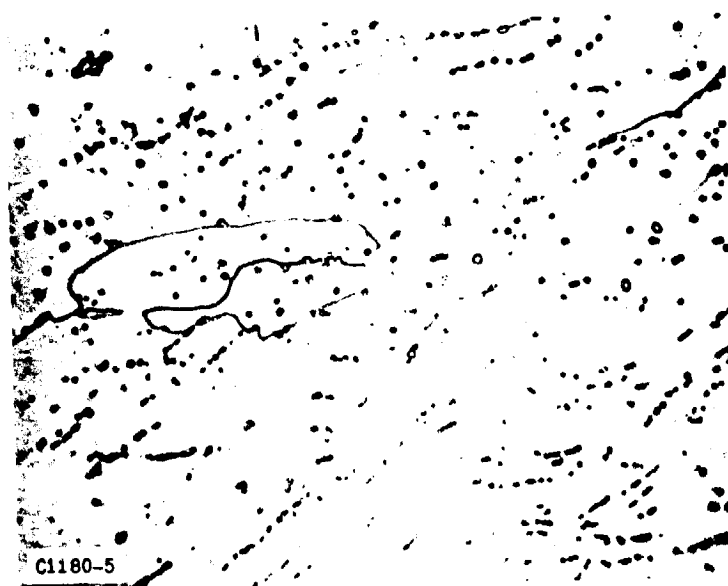
b) Annealed 1 Hour at 2900°F (1593°C)

Figure F-4. Longitudinal Microstructure of 2.0-Inch (5.1-cm)-Diameter Cb-132M Alloy Rod.

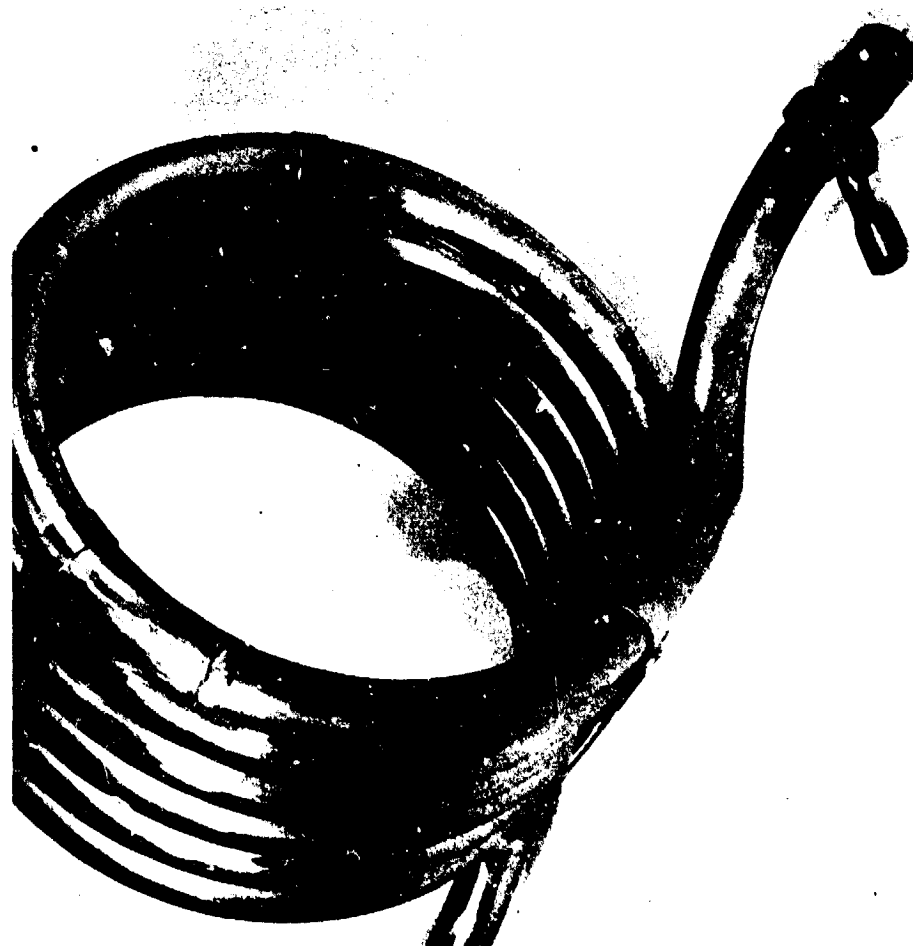
Figure K-22. Top of the Boiler Following Final Repair Welding.
(Orig. P68-9-31B)
